Repairing a Notebook PC

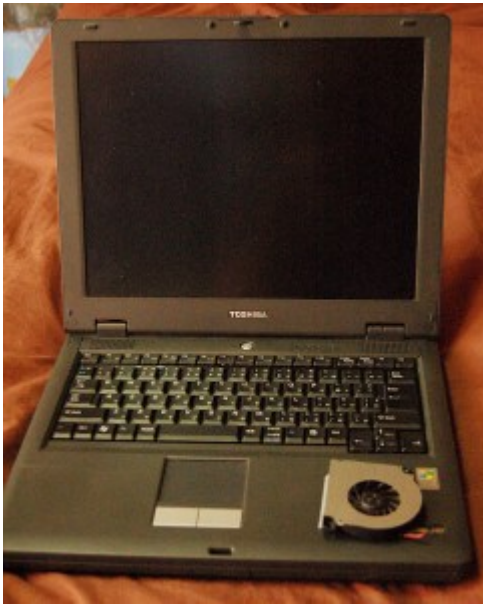
Toshiba Satellite J40. Broken CPU fan on the bottom right

With two junk laptops gotten for free, I did what I would not do with a customer's laptop PC. I unscrewed each and every screw in both the top and bottom of the Toshiba Satellite J40 laptop PC, put them in order on my desk, removed the bottom plastic case from the top case, removed the defective CPU fan, and replaced it with the CPU fan from the Toshiba laptop with the broken monitor. Because the size of the fan was not the same, it could only be secured with one screw. But it was enough.
